Pre-Demolition Environmental Inspection Summary Report

| House No: | 3083 McCollum Ave, Mt. Morris Township, MI |

Global Project No. EE16011

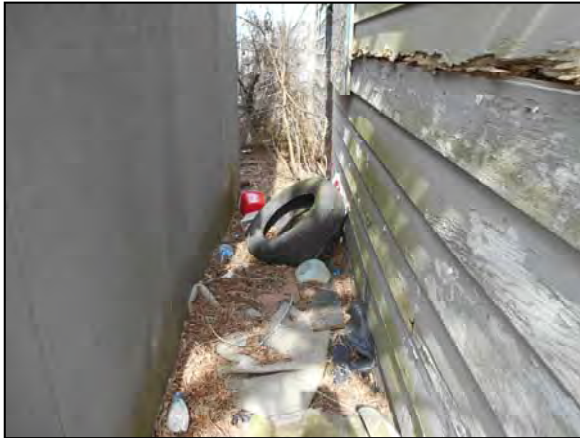
Tire
Between Garage and Shed
